Road & Railroad Crossing Inventory Mauvais & Big Coulee

**Bureau of Reclamation
Dakotas Area Office**

September 1999

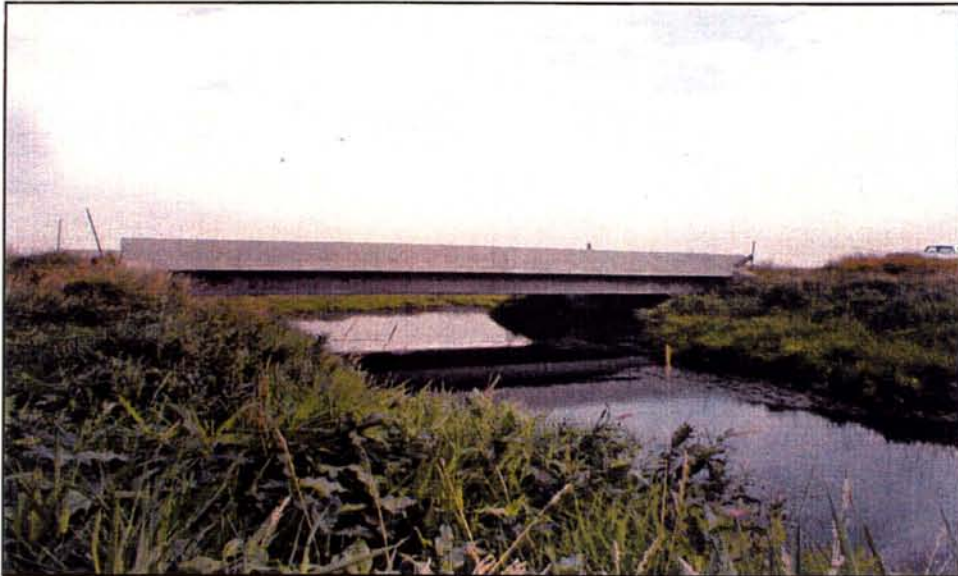
M1 Downstream side of concrete bridge on Maza road, in good condition,
Section 36 & 2, T157 & 156N, R66W, N 502979.46, E 2338124.89,
Elevation 1438.6 @ ∇ of coulee.

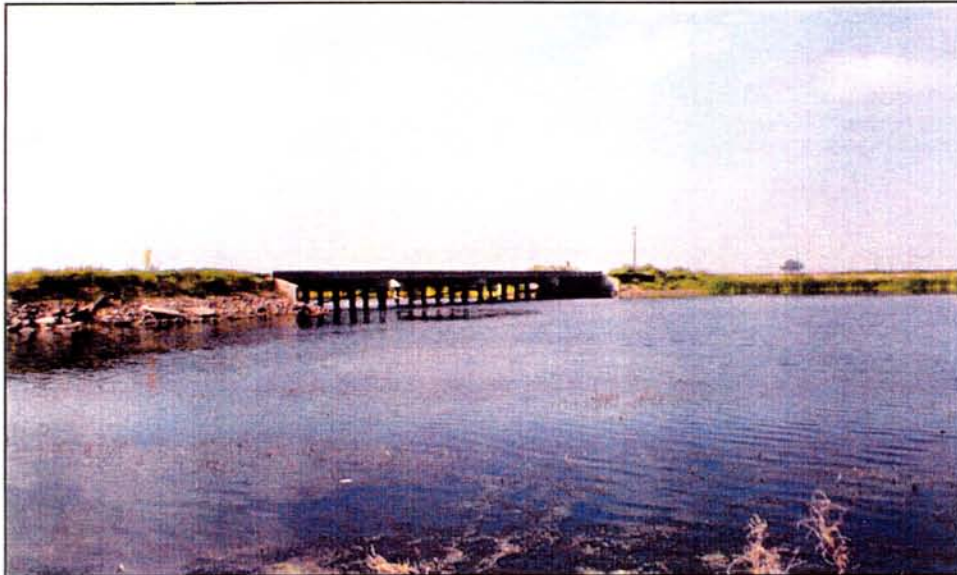
M2 Upstream side of concrete bridge, in fair condition, 8 feet of water (8-11-98), Section 25 & 36, T157N, R66W, N 508282.80, E 2337598.17, Elevation 1436.6 @ ∇ of Coulee.

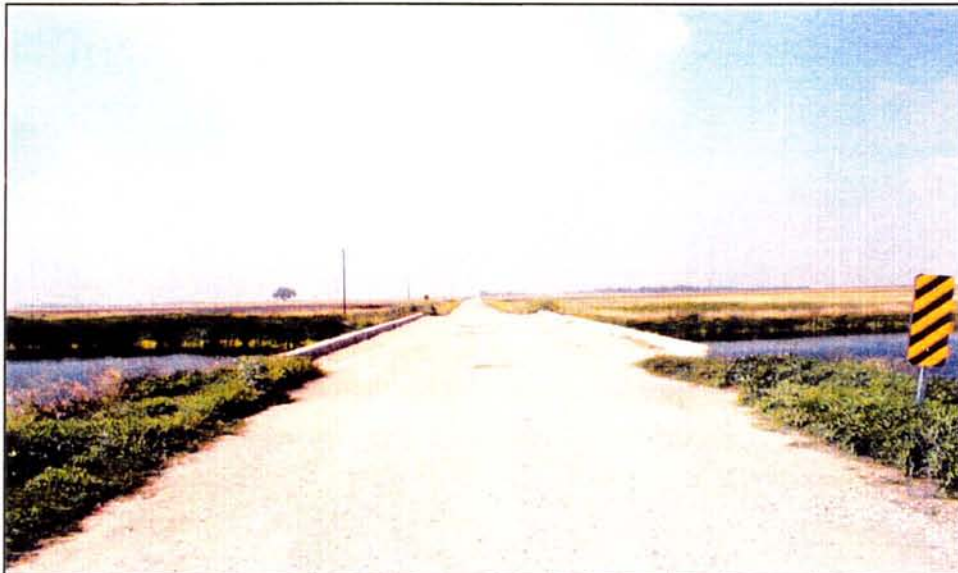
M2 Center of concrete bridge, in fair condition, looking west, 22.4' wide & 132.0' long, Section 25 & 36, T157N, R66W, N 508271.15, E 2337598.72, Elevation 1452.1 @ center of bridge.

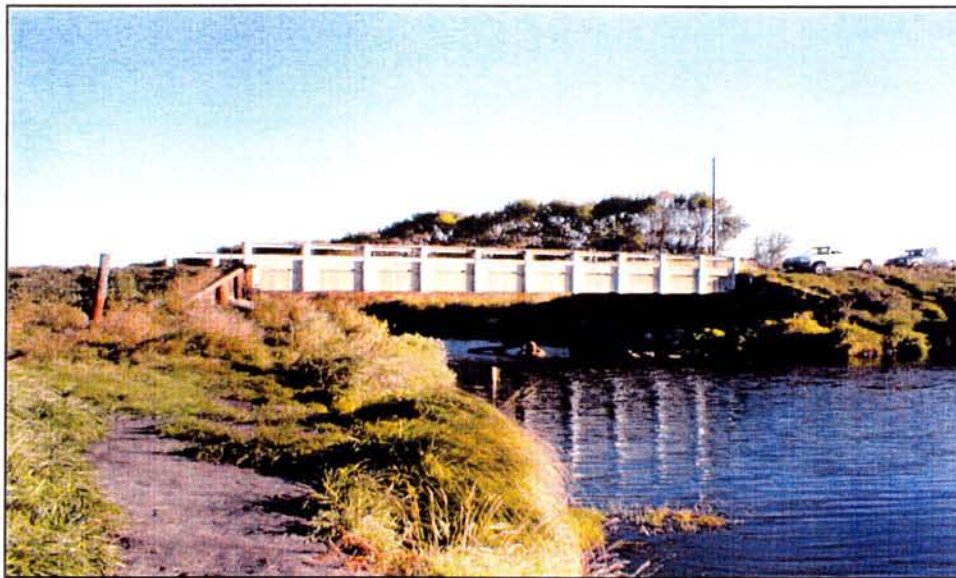
M3 Downstream side of concrete bridge in good condition, 5.1 feet of water (9-30-98), Section 7 & 18, T157N, R65W, N 524144.54, E 2340890.60, Elevation 1440.5 @ Φ of coulee.

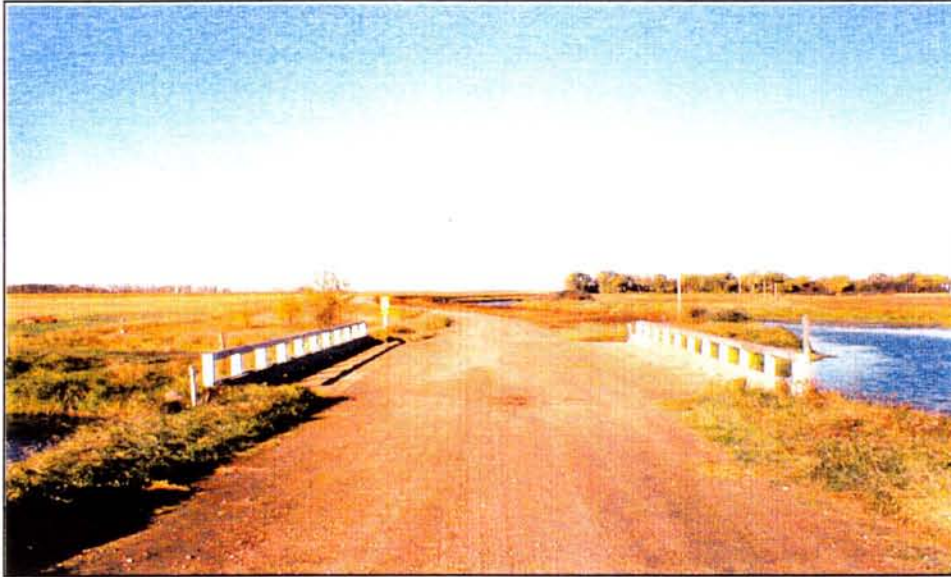
M3 Center of concrete bridge, in good condition, looking west, 30.3 wide & 59.8 long, Section 7 & 18, T157N, R65W, N 524160.21, E 2340889.39, Elevation 1456.5 @ center of bridge.

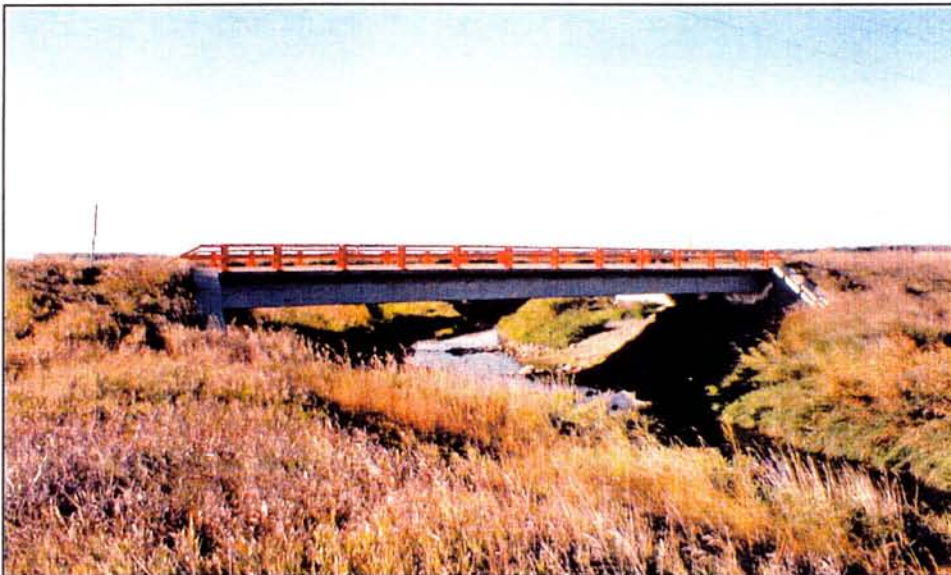
M4 Upstream side of concrete bridge, in good condition, 0.5 feet of water (9-30-98), Section 6 & 7, T157N, R65W, N 529446.70, E 2339970.77, Elevation 1444.7 @ Φ of coulee.

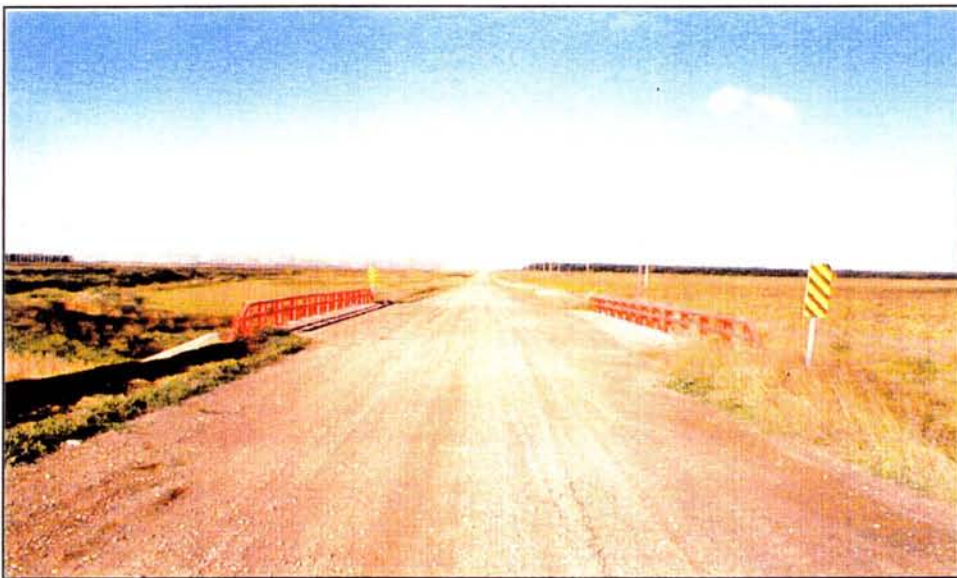
M4 Center of concrete bridge, in good condition, looking west, 32.5 feet wide & 74.6 feet long, Section 6 & 7, T157N, R65W, N 529431.30, E 2339965.46, Elevation 1461.1 @ center of bridge.

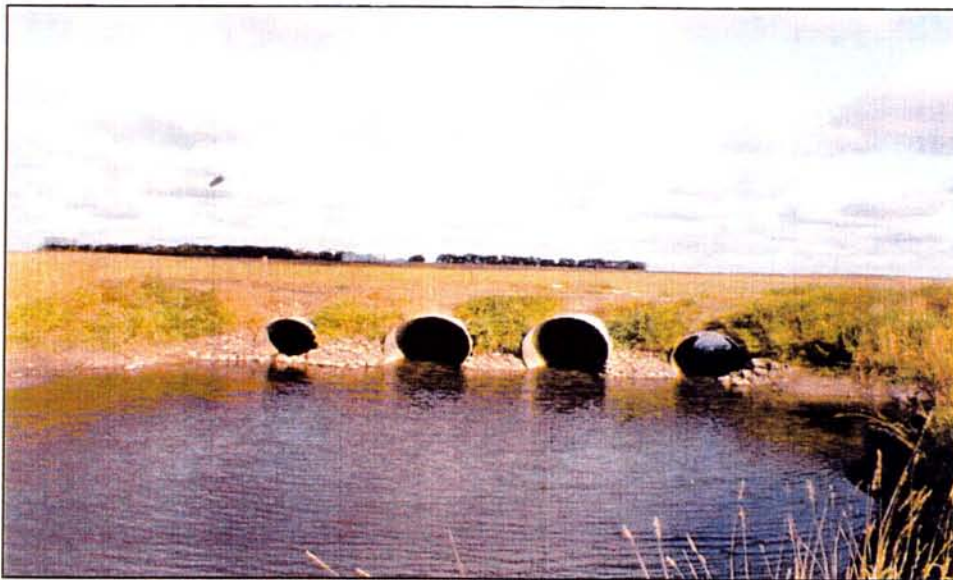
M5 Downstream side of four 72" CMP's, in good condition, 1.0 foot of water (9-30-98), Section 30 & 31, T158N, R65W, east to west N & E,
 N 540003.18, E 2340749.39, Elevation 1453.3 @ invert of CMP,
 N 540004.26, E 2340740.00, Elevation 1453.2 @ invert of CMP,
 N 540004.67, E 2340730.30, Elevation 1452.8 @ invert of CMP,
 N 540004.85, E 2340719.56, Elevation 1453.6 @ invert of CMP.

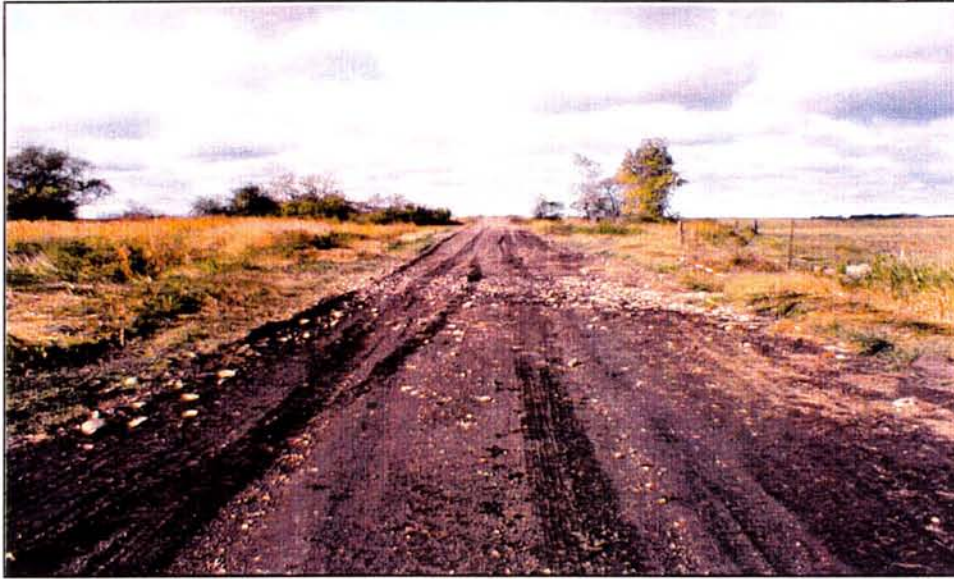
M5 Center of road crossing of four 72" CMP's, looking west, Section 30 & 31, T158N, R65W, N 540025.35, E 2340734.44, Elevation 1459.6 @ center of road.

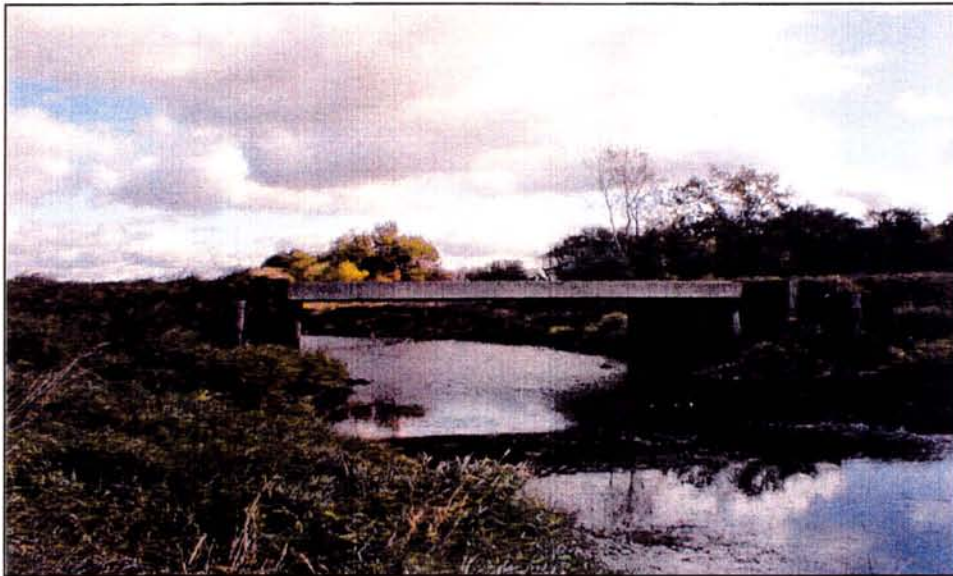
M6 Upstream side of concrete & wood bridge, in fair condition, 6.0 feet of water (9-30-98), Section 25 & 30, T158N, R65 & 66W, N 542470.75, E 2339421.08, Elevation 1449.2 @ Φ of coulee.

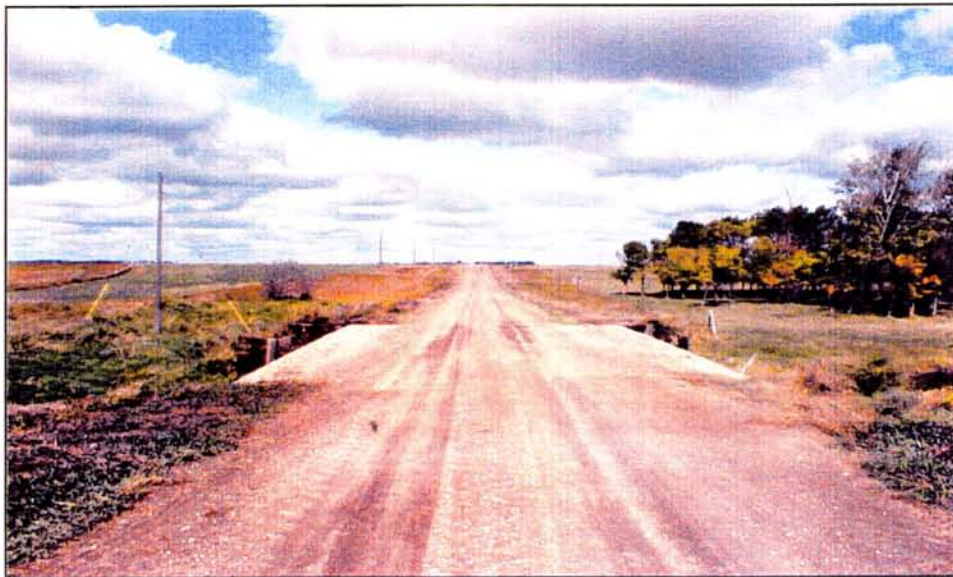
M6 Center of concrete & wood bridge, looking north, in fair condition, 24.0 wide & 45.2 long, Section 25 & 30, T158N, R65 & 66W, N 542469.94, E 2339433.28, Elevation 1467.0 @ center of bridge.

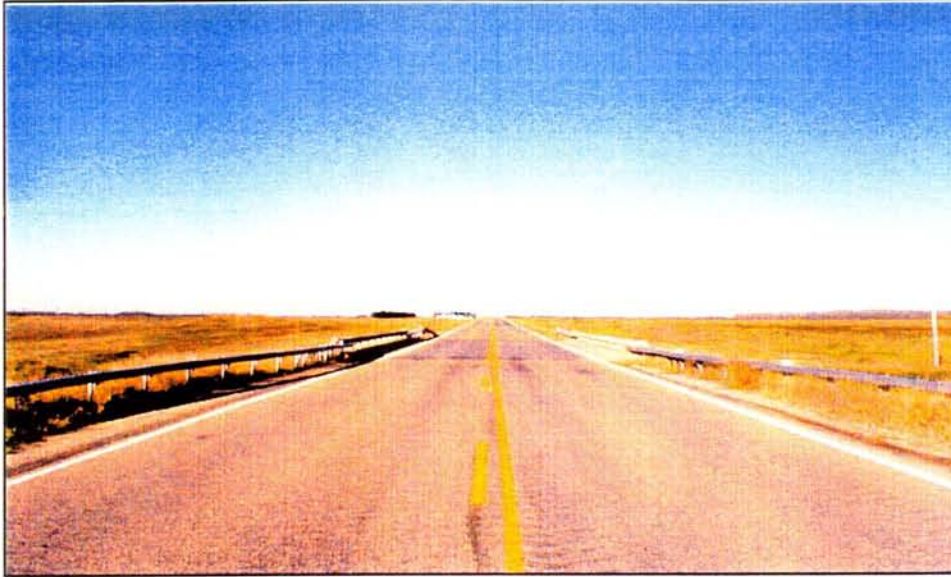
M7 Center of concrete bridge on N.D Hwy. 17, looking west, in good condition, 35.7' wide & 95.0' long, Section 24 & 25, T158N, R66W, N 545246.95, E 2336723.12, Elevation 1469.9 @ center of bridge.

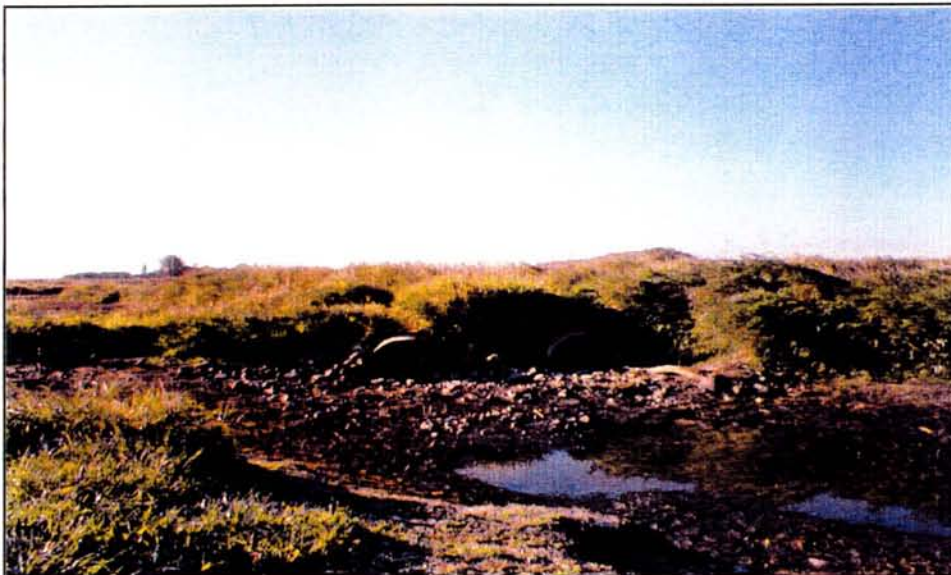
M8 Upstream side of two 30"x42" CMP's, in good condition, no water, Section 13 & 24, T158N, R66W, N 550513.24, E 2334611.67, Elevation 1457.9 @ invert of east CMP, N 550512.31, E 2334602.43, Elevation 1458.2 @ invert of west CMP.

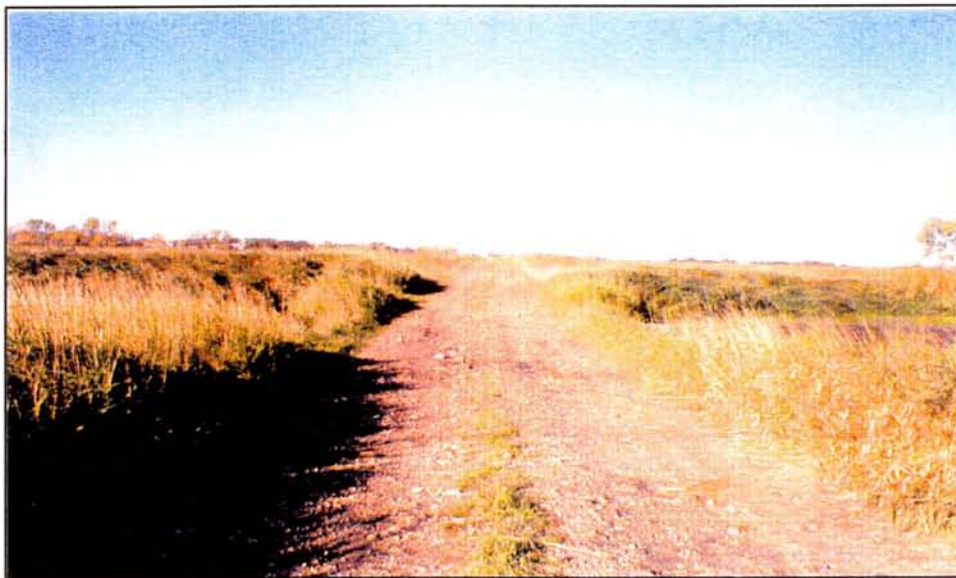
M8 Center of trail at two 30" x 42" CMP's, looking west, Section 13 & 24, T158N, R66W, N 550496.24, E 2334607.07, Elevation 1461.0 @ center of trail.

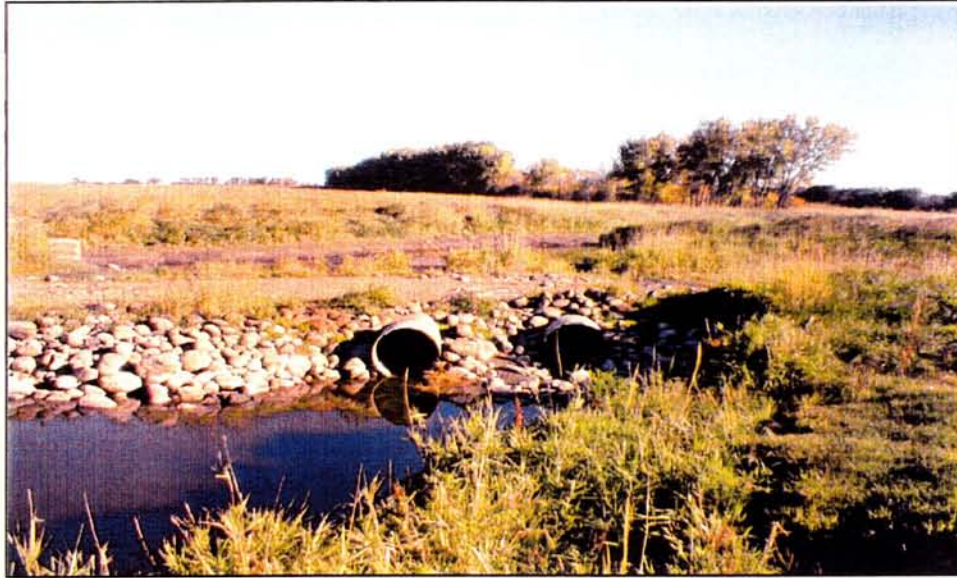
M9 Upstream side of two 36" CMP's, in good condition, 0.1 foot of water (10-1-98), Section 14 & 23, T158 N, R66W, N 550473.42, E 2333869.66, Elevation 1457.5 @ invert of east CMP, N 550471.26, E 2333860.99, Elevation 1457.5 @ invert of west CMP.

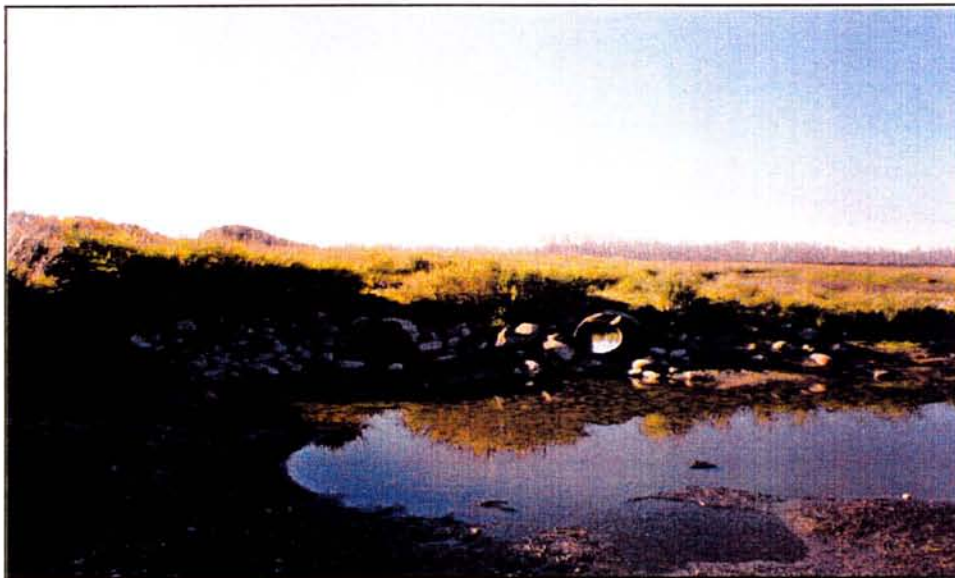
M9 Downstream side of two 36" CMP's, in good condition, no water (10-1-98), Section 14 & 23, T158N, R66W, N550503.44, E 2333877.58, Elevation 1457.4 @ invert of east CMP, N 550504.78, E 2333867.93, Elevation 1457.7 @ invert of west CMP.

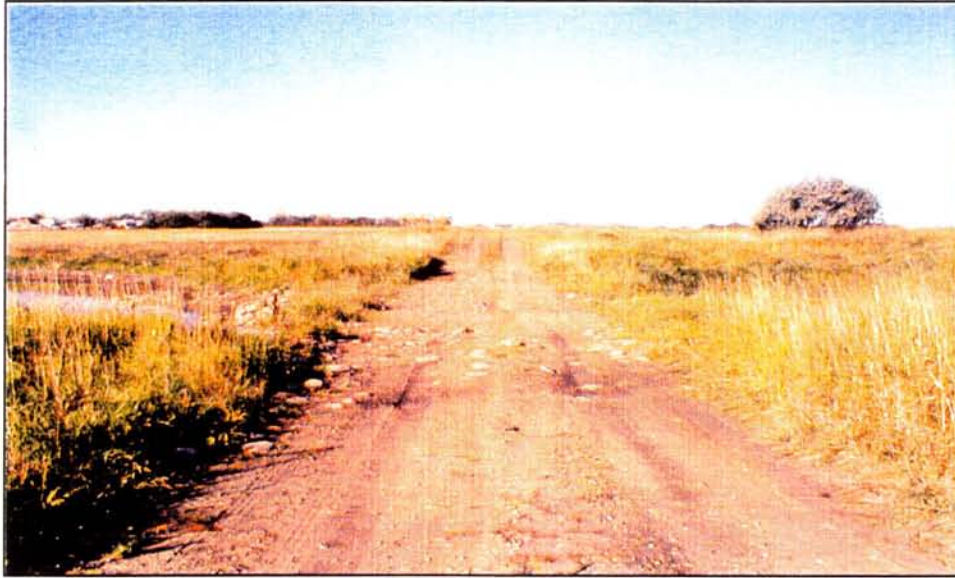
M9 Center of trail crossing of two 36" CMP's, looking west, Section 14 & 23, T158N, R66W, N 550488.37, E 2333868.61, Elevation 1460.8 @ center of trail.

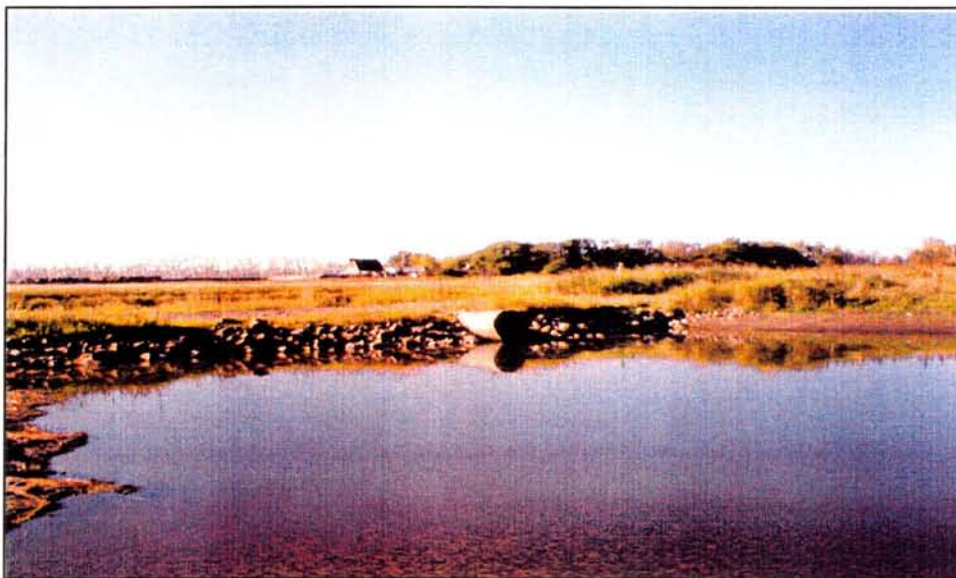
M10 Upstream side of one 36" CMP, in good condition, 0.1 foot of water (10-1-98), Section 14 & 23, T158N, R66W, N 550510.13, E 2332622.09, Elevation 1458.9 @ invert of CMP.

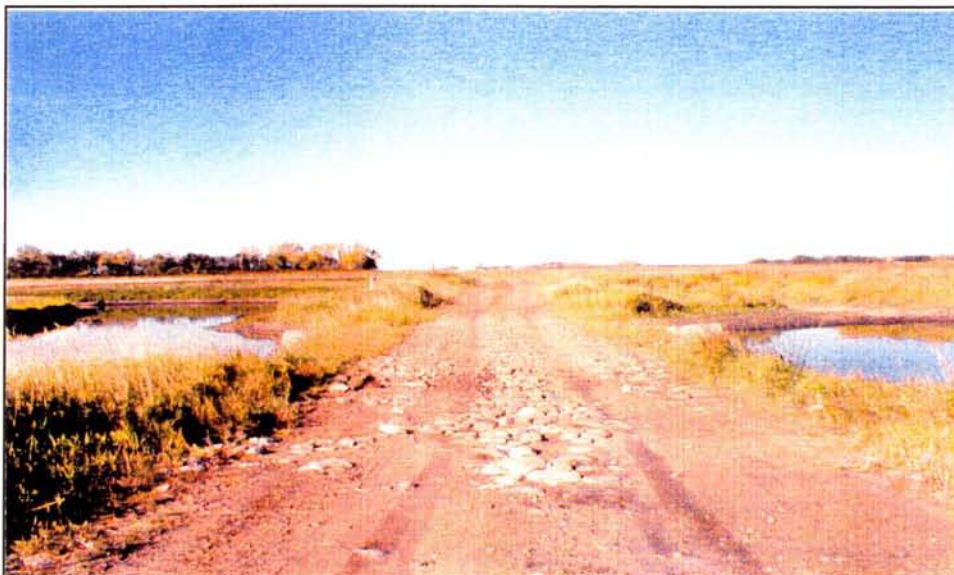
M10 Center of trail crossing of one 36" CMP, looking west, Section 14 & 23, T158N, R66W, N 550490.48, E 2332620.84, Elevation 1461.7 @ center of trail.

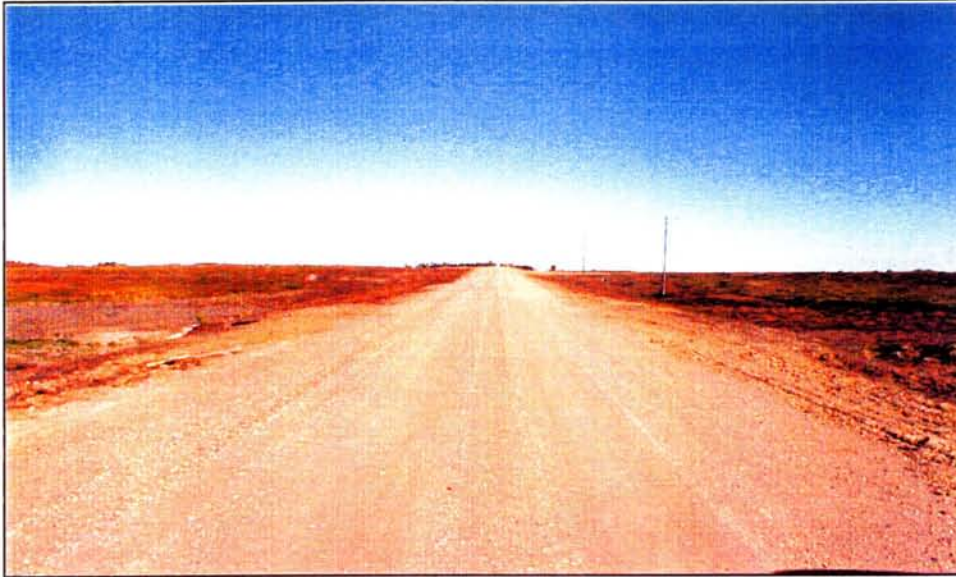
M11 Center of road crossing of box culvert, looking north 54.5 feet wide & 39.9 feet long, Section 10 & 11, T158N, R66W, N 556415.02, E 2328638.97, Elevation 1473.3 @ center of road.

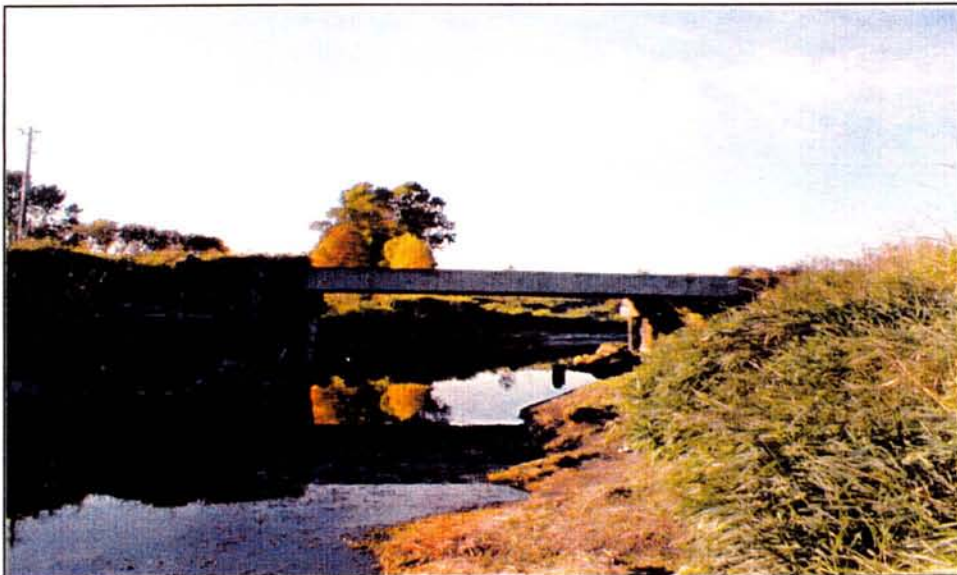
M12 Upstream side of concrete & wood bridge, in fair condition, 3 feet of water (10-2-98), Section 9, T158N, R66W, N 558986.71, E 2319971.78, Elevation 1465.0 @ Φ of coulee.

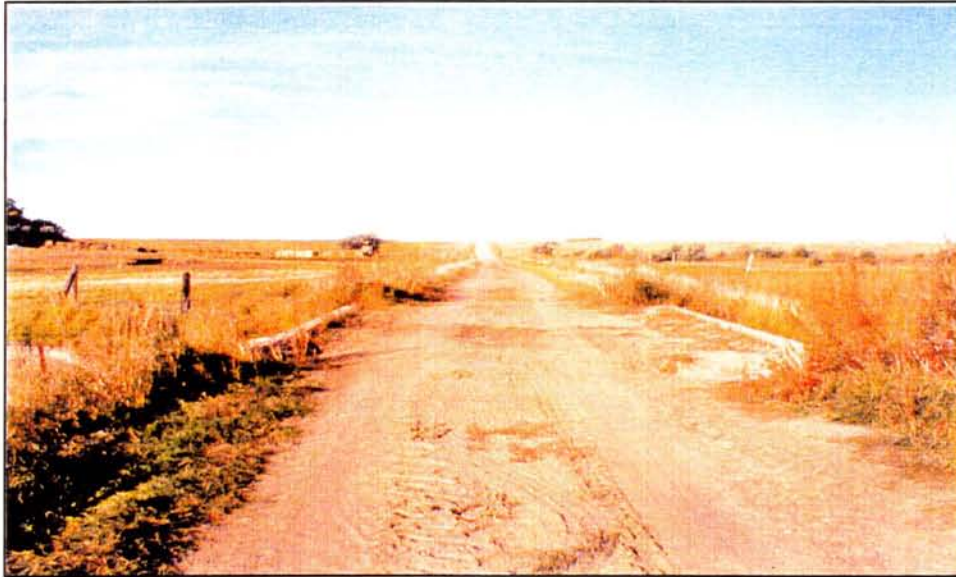
M13 Center of concrete bridge looking west, in poor condition, 19.2 feet wide, 24.5 feet long, Section 33 & 4, T158 & 159N, R66W, N 566156.95, E 2322347.76, Elevation 1480.1 @ center of bridge.

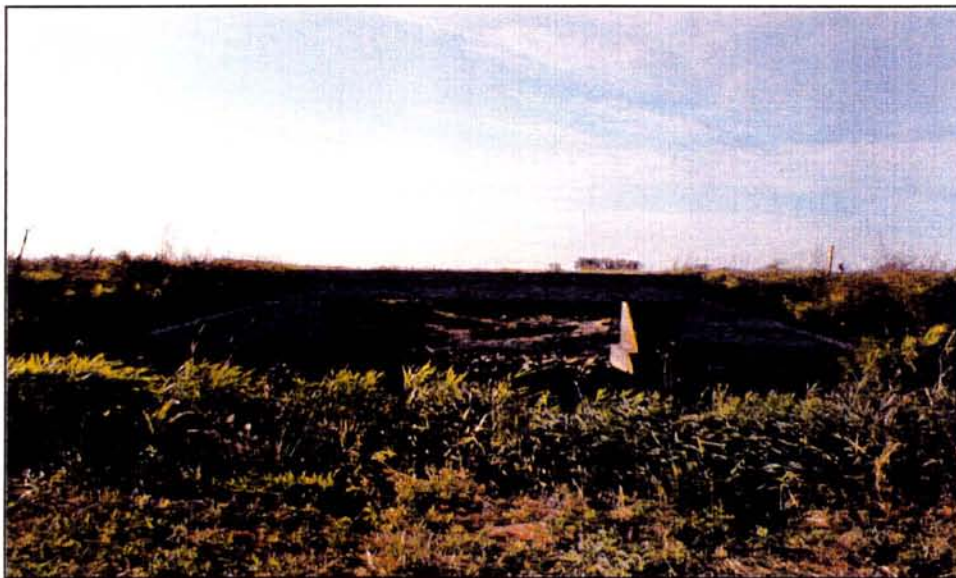
M14 Upstream side of concrete bridge, in fair condition, no water (10-2-98), Section 27 & 34, T159N, R66W, N 571491.56, E 2324231.93, Elevation 1474.7 @ Φ of coulec.

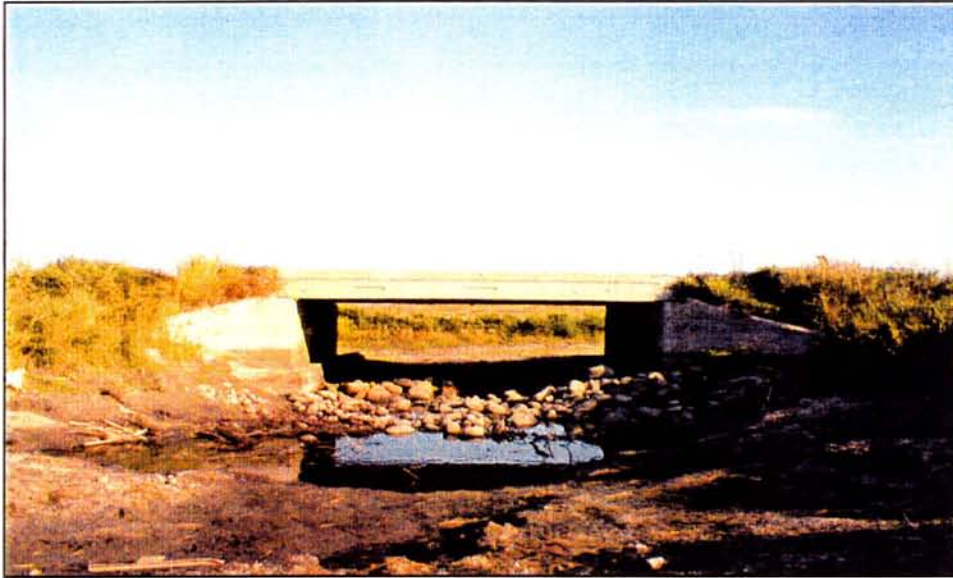
M14 Downstream side of concrete bridge, in fair condition, no water (10-2-98), Section 27 & 34, T159N, R66W, N 571468.90, E 2324232.13, Elevation 1474.5 @ ∇ of coulee.

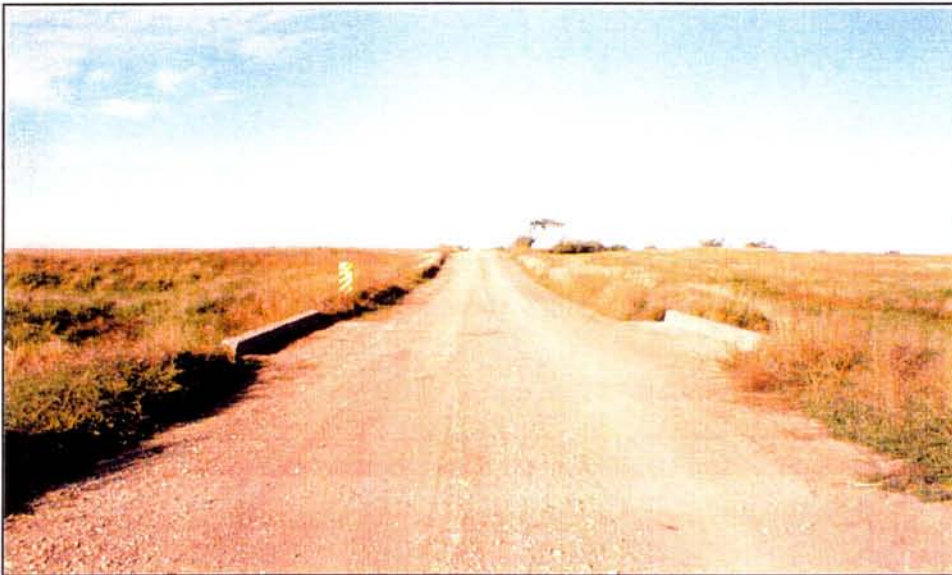
M14 Center of concrete bridge in fair condition, looking west, 22.5 feet wide & 24 feet long, Section 27 & 34, T159N, R66W, N 571480.01, E 2324231.88, Elevation 1484.0 @ center of bridge.

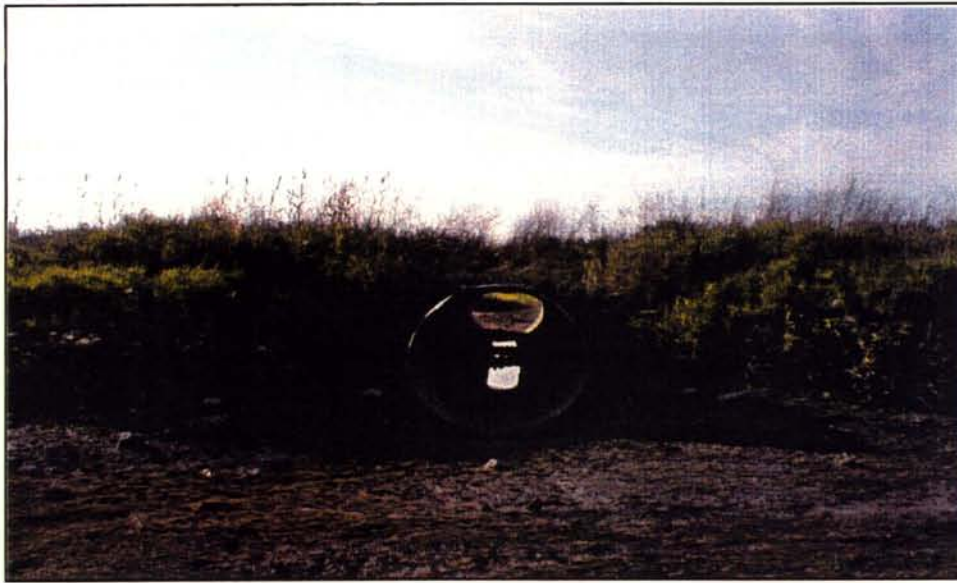
M15 Upstream side of 72" CMP located 172 ft. east of bridge, in good condition, no water (10-2-98), Section 27 & 34, T159N, R66W, N 571509.02, E 2324400.66, Elevation 1476.2 @ invert of CMP.

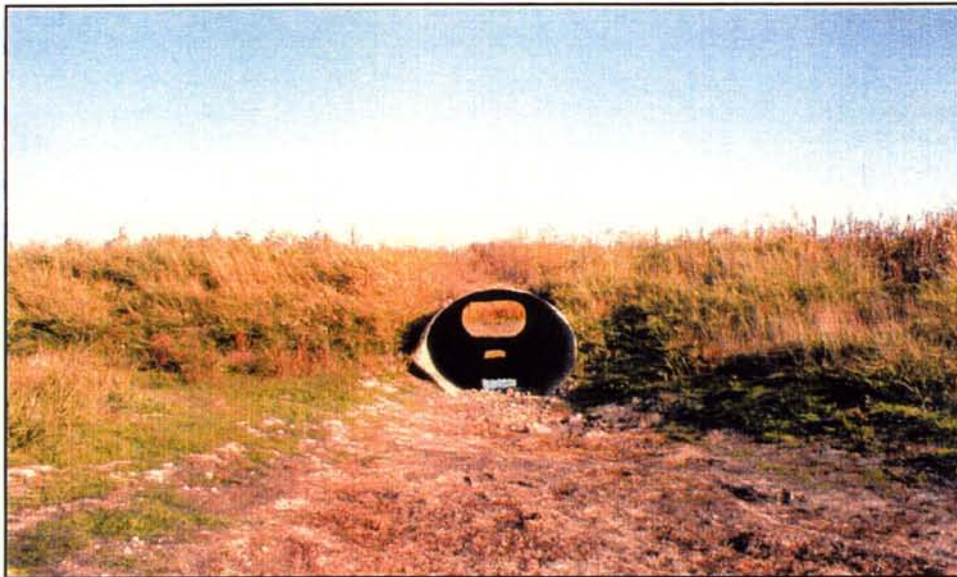
M15 Downstream side of 72" CMP located 172 ft. east of bridge, in good condition, no water (10-2-98), Section 27 & 34, T159N, R66W, N 571455.12, E 2324403.74, Elevation 1476.4 @ invert of CMP.

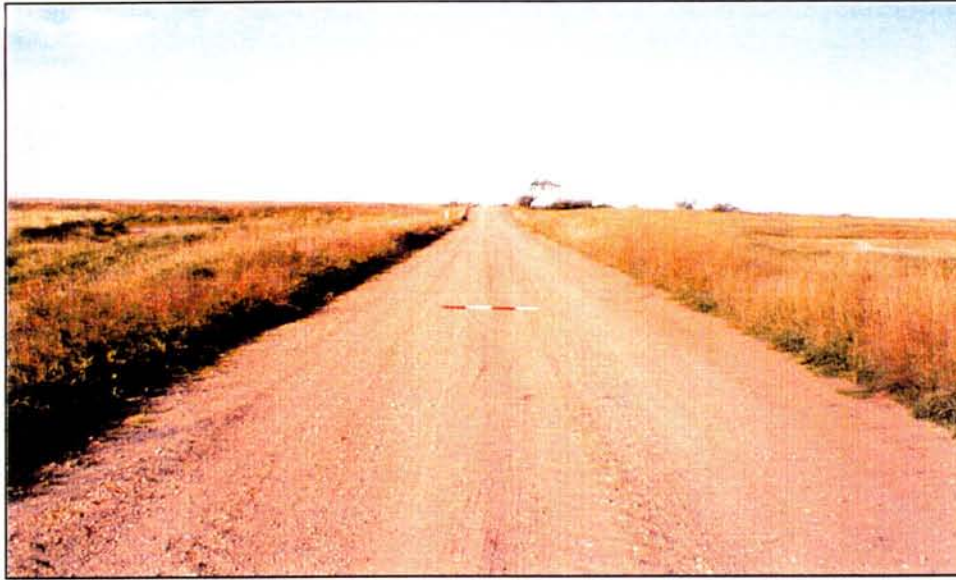
M15 Center of road crossing, 72" CMP located 172 feet east of bridge, looking west, Section 27 & 34, T159N, R66W, N 571481.75, E 2324402.17, Elevation 1484.1 @ center of road.

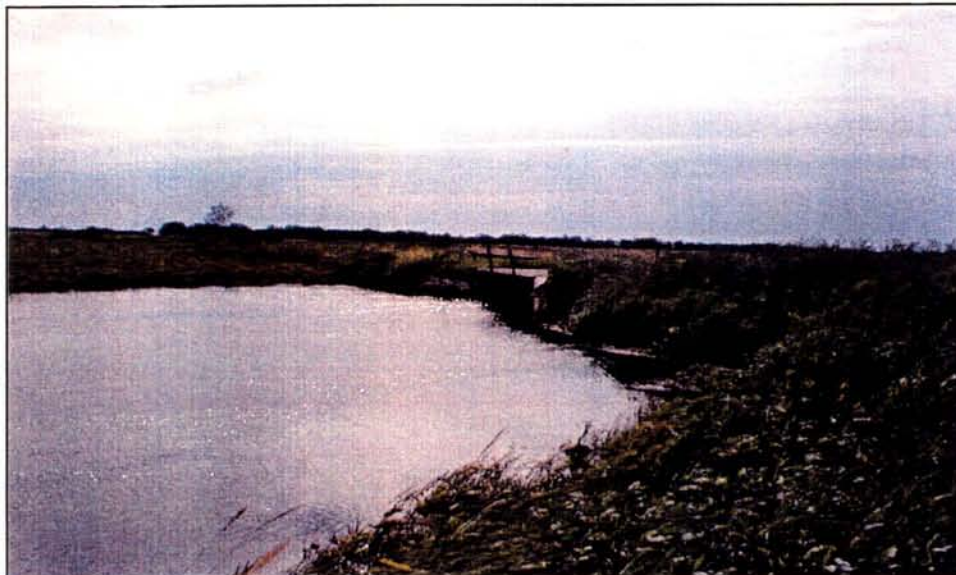
M16 Upstream side of concrete bridge, in poor condition, 4.1 feet of water (7-30-99), Section 21 & 28, T159N, R66W, N 576735.45, E 2322663.57, Elevation 1468.9 @ Φ of coulee.

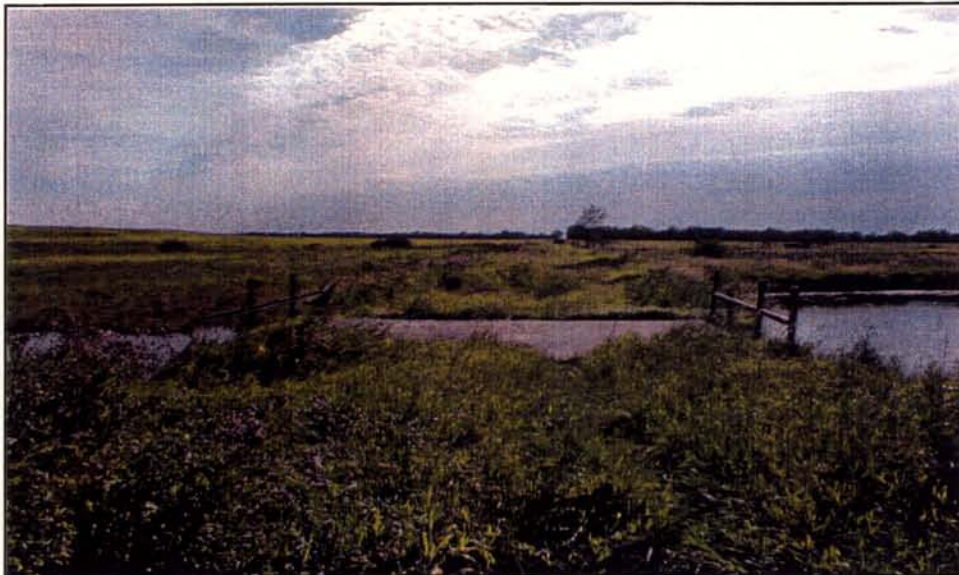
M16 Center of concrete bridge, in poor condition, looking east, 20 feet wide & 18 feet long, Section 21 & 28, T159N, R66W, N 576725.05, E 2322663.06, Elevation 1485.4 @ center of bridge.

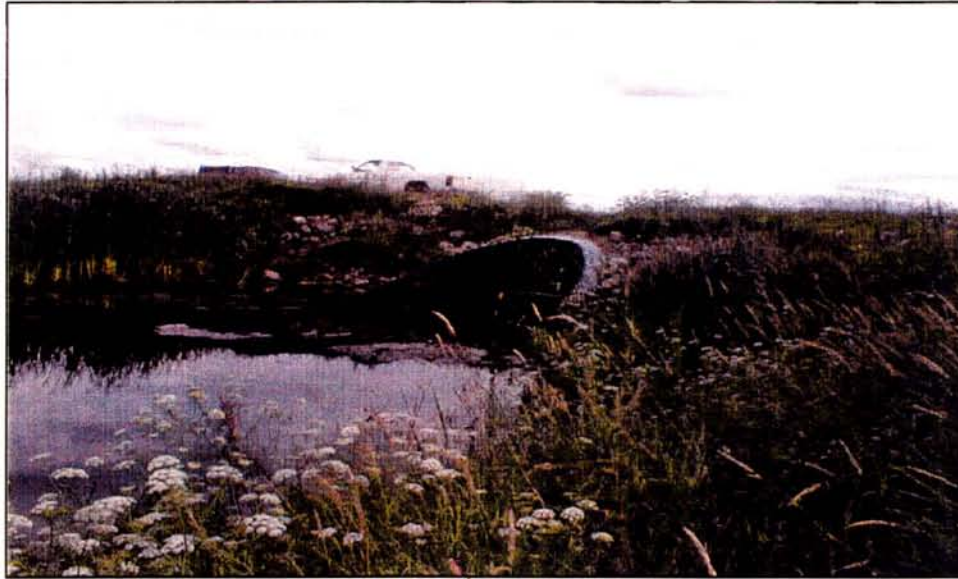
M17 Upstream side of one 96" CMP, in new condition, 3.3 feet of water (7-30-99), Section 16 & 21 T159N, R66W, N 582012.88, E 2321083.21, Elevation 1472.7, @ invert of CMP.

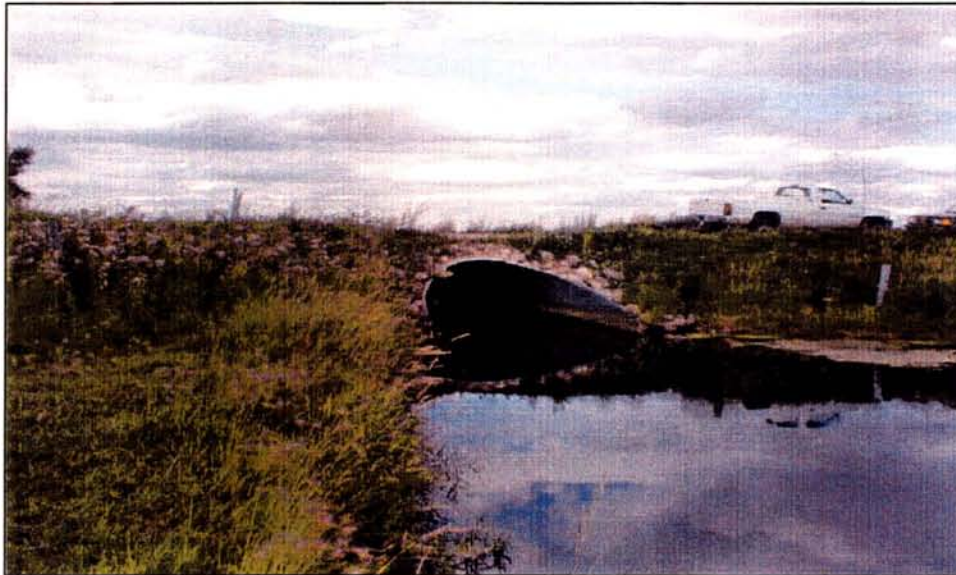
M17 Downstream side of one 96" CMP, in new condition, 3 feet of water (7-30-99), Section 16 & 21 T159N, R66W, N 581979.19, E 2321084.17, Elevation 1473.1 @ invert of CMP.

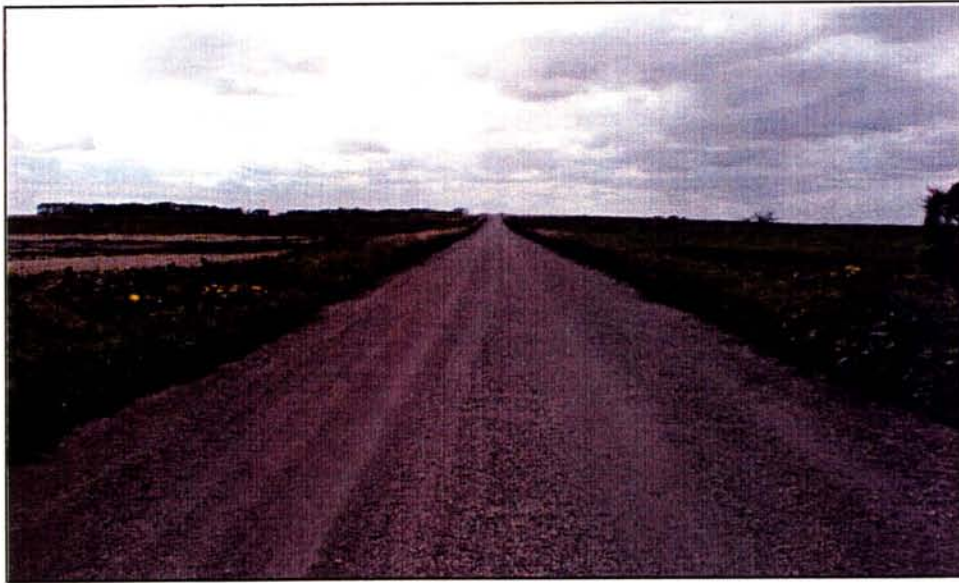
M17 Center of road crossing at 96" CMP, looking west, Section 16 & 21, T159N, R66W, N 581993.72, E 2321084.31, Elevation 1490.9 @ center of road crossing.

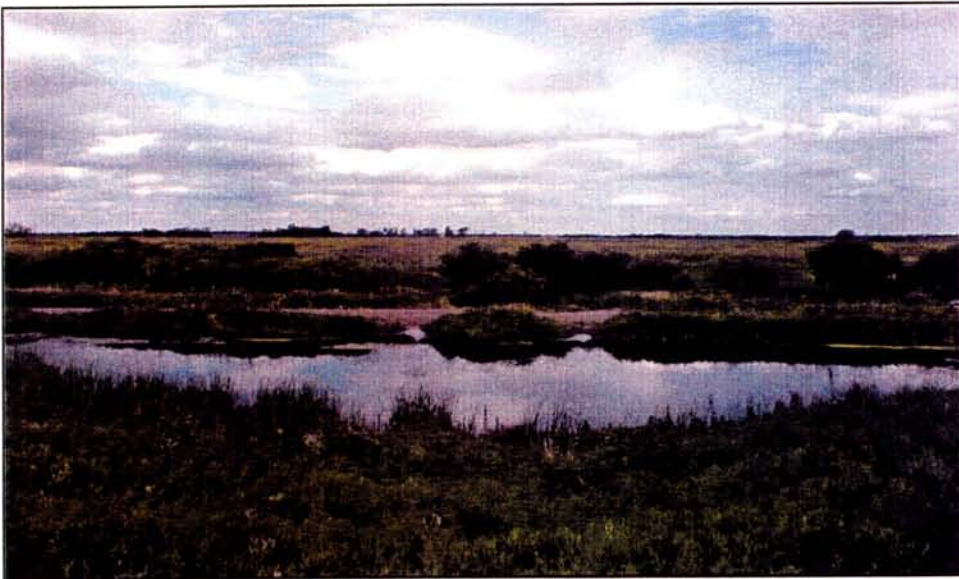
M18 Upstream side of two 48" CMP's, in good condition, 3.9 feet & 3.5 feet of water (7-30-99), Section 17 & 16, T159N, R66W, N 586368.74, E 2317541.46, Elevation 1485.9, @ invert of south CMP, N 586388.61, E 2317539.22, Elevation 1486.3 @ invert of north CMP.

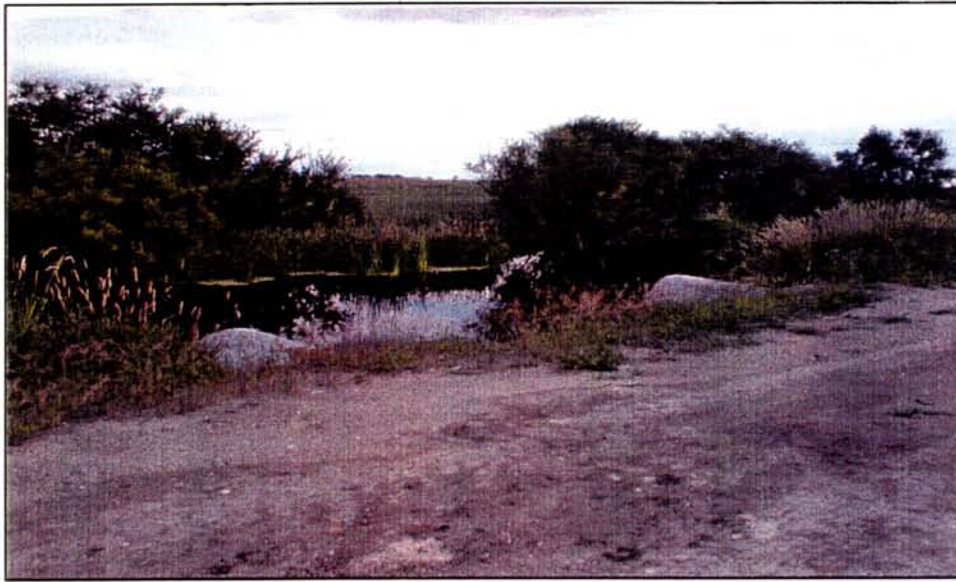
M18 Downstream side of two 48" CMP, in good condition, 2.7 & 3 feet of water (7-30-99), Section 17 & 16, T159N, R66W, N 586366.32, E 2317580.33, Elevation 1487.1, @ invert of south CMP, N 586388.17, E 2317578.60, Elevation 1486.8 @ invert of north CMP.

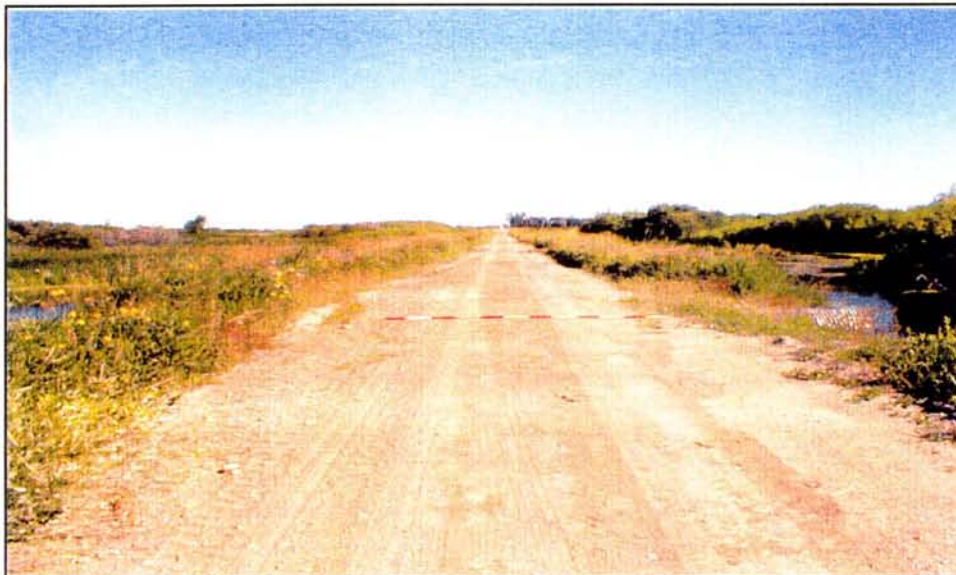
M18 Center of road crossing, between two 48" CMP's, looking north, Section 17 & 16, T159N, R66W, N 586376.10, E 2317559.58, Elevation 1491.6 @ center of road crossing between CMP's.

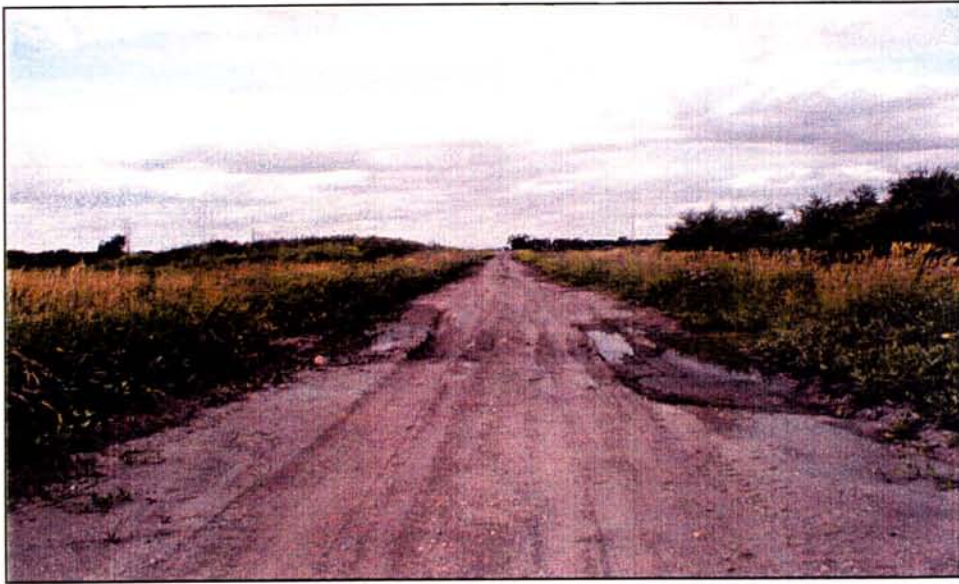
M19 Center of road crossing, may have CMP, under water & mud, could not locate, located 170 feet north of M18 CMP, looking north, Section 17 & 16, T159N, R66W, N 586562.90, E 2317557.79, Elevation 1490.1 @ center of road crossing, between water.

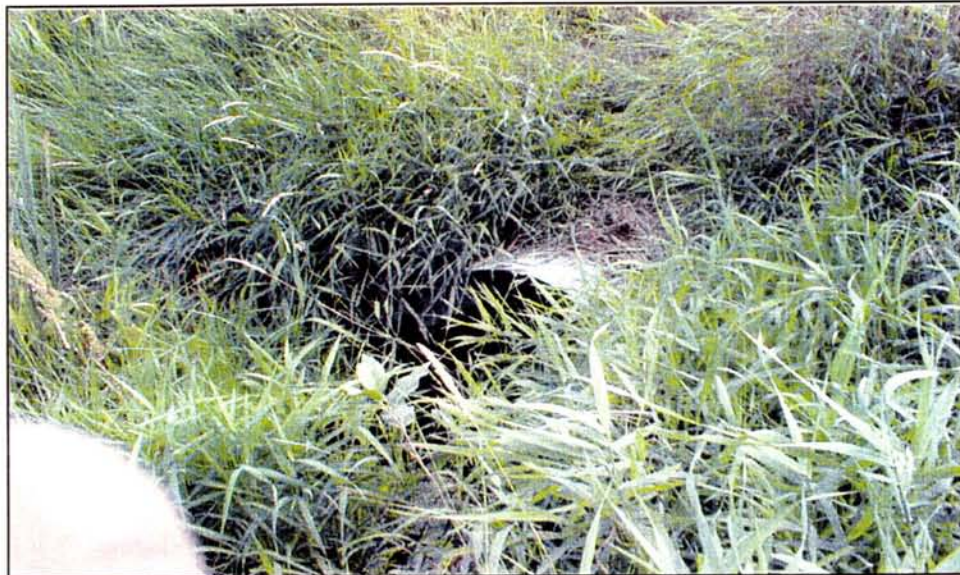
M20 Upstream side of one 36" CMP, in good condition, 1.4 feet of water (8-2-99), Section 9 & 16, T159N, R66W, N 587237.23, E 2317575.64, Elevation 1488.5 @ invert of CMP.
